Appleton Public Library

council meeting

existing conditions | Appleton Public Library

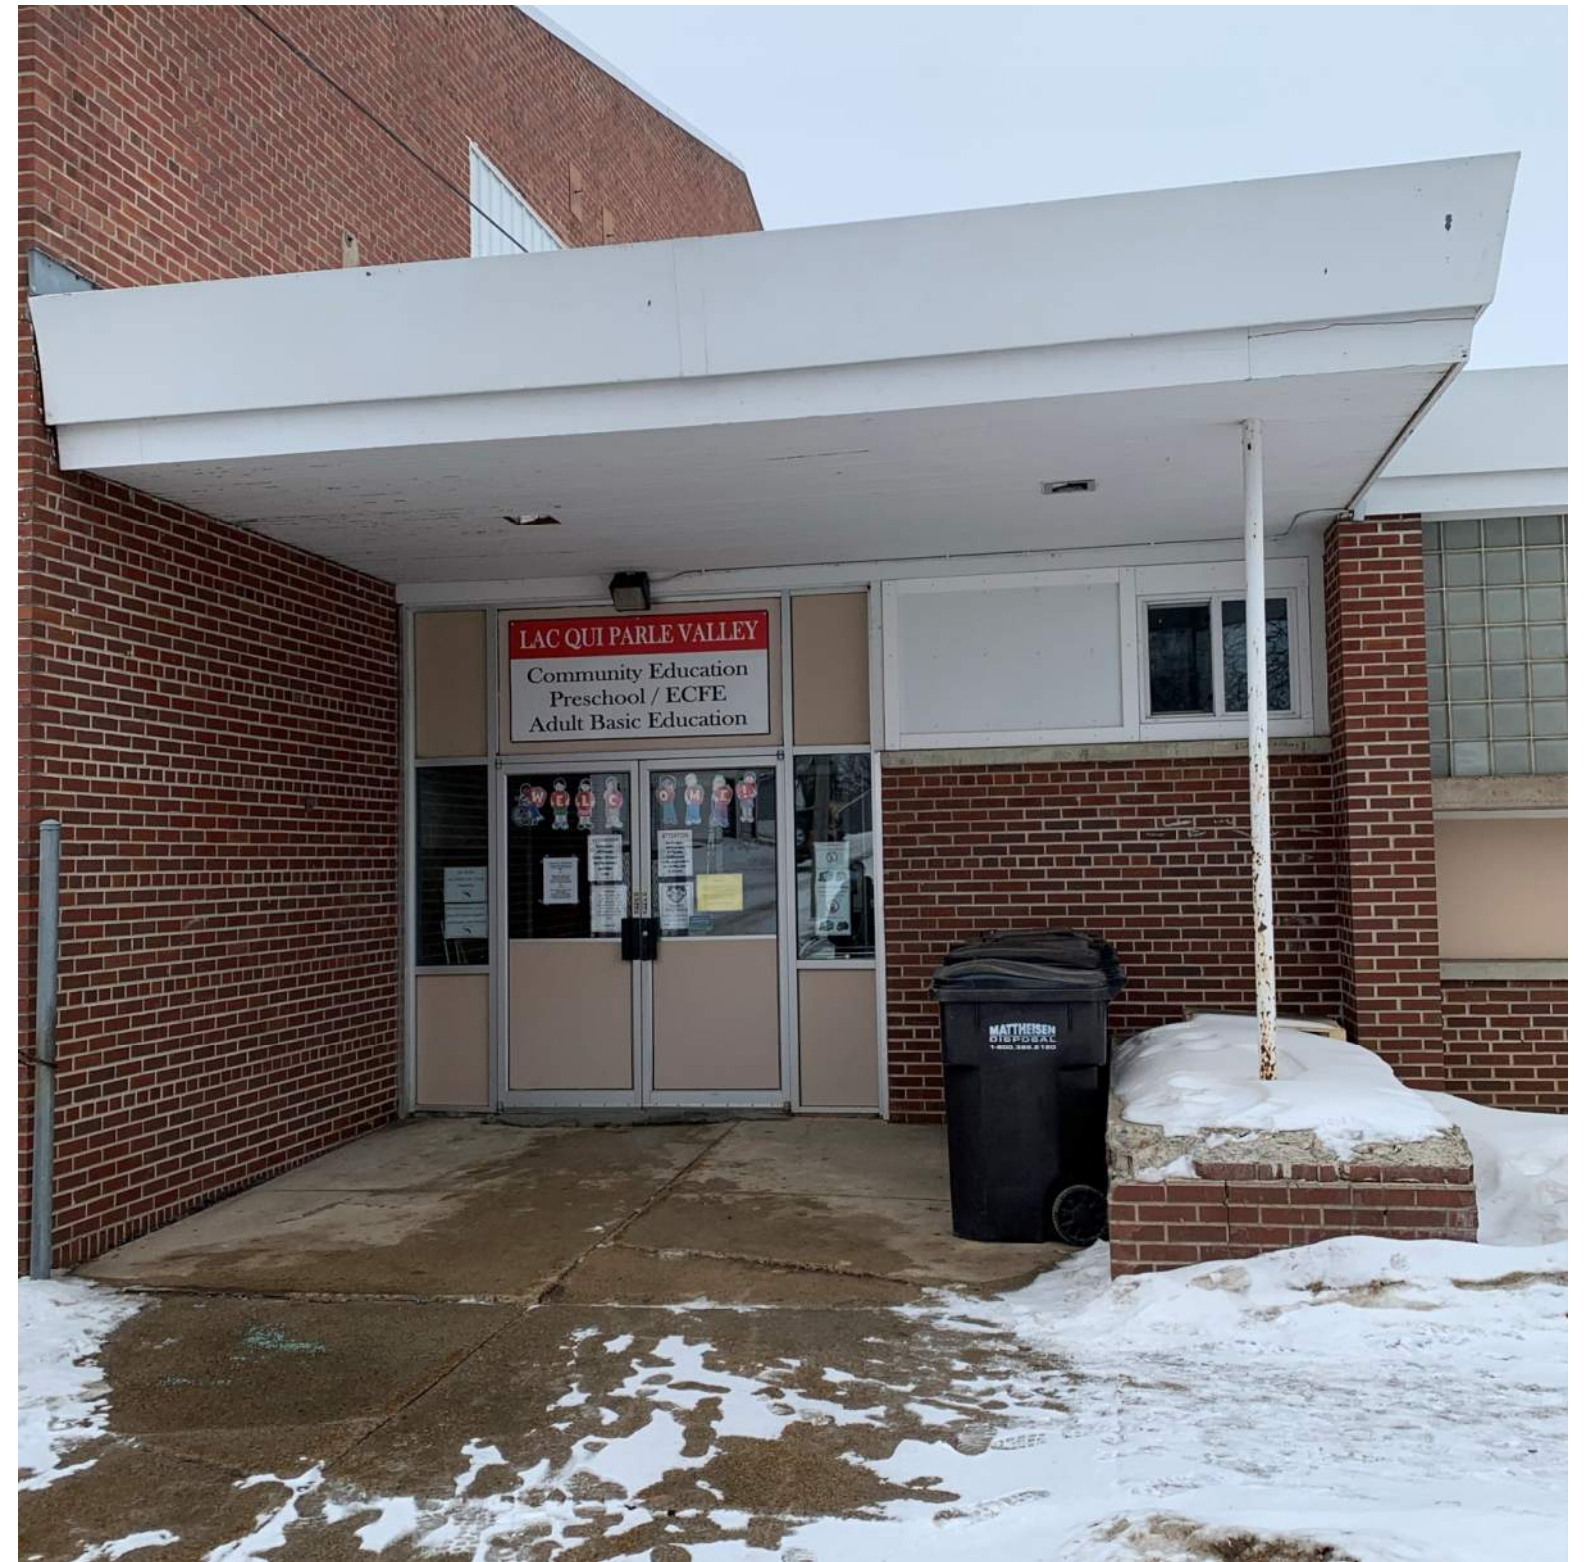
Emergency exit only, door can remain as-is.

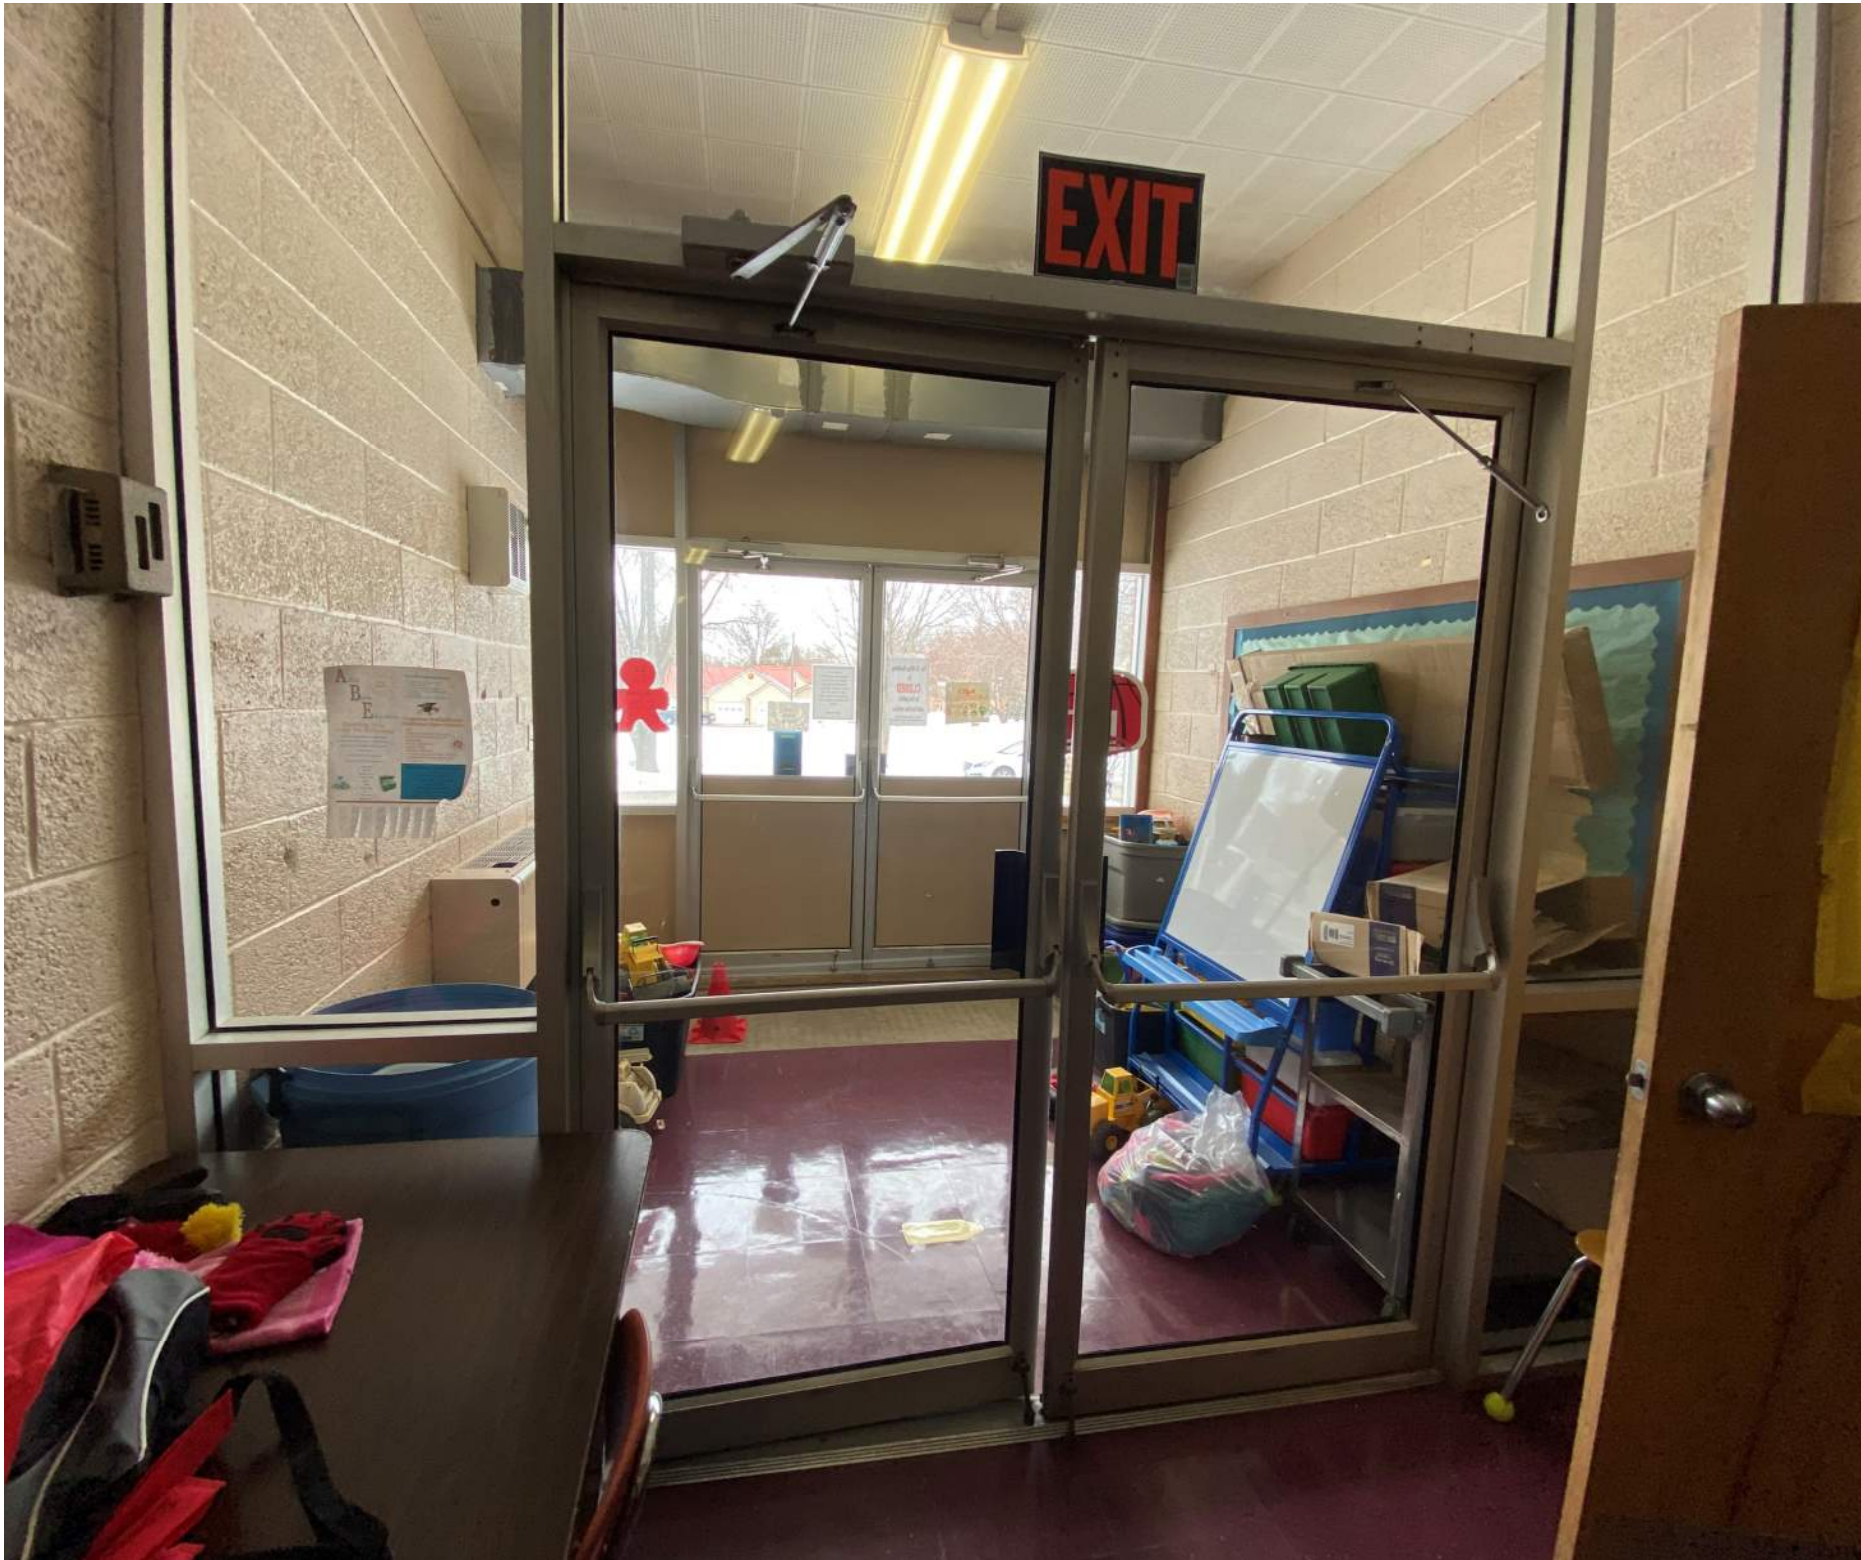
Existing vestibule can remain in place as new library entrance.
Could be rebuilt to incorporate after-hours book drop next to door.

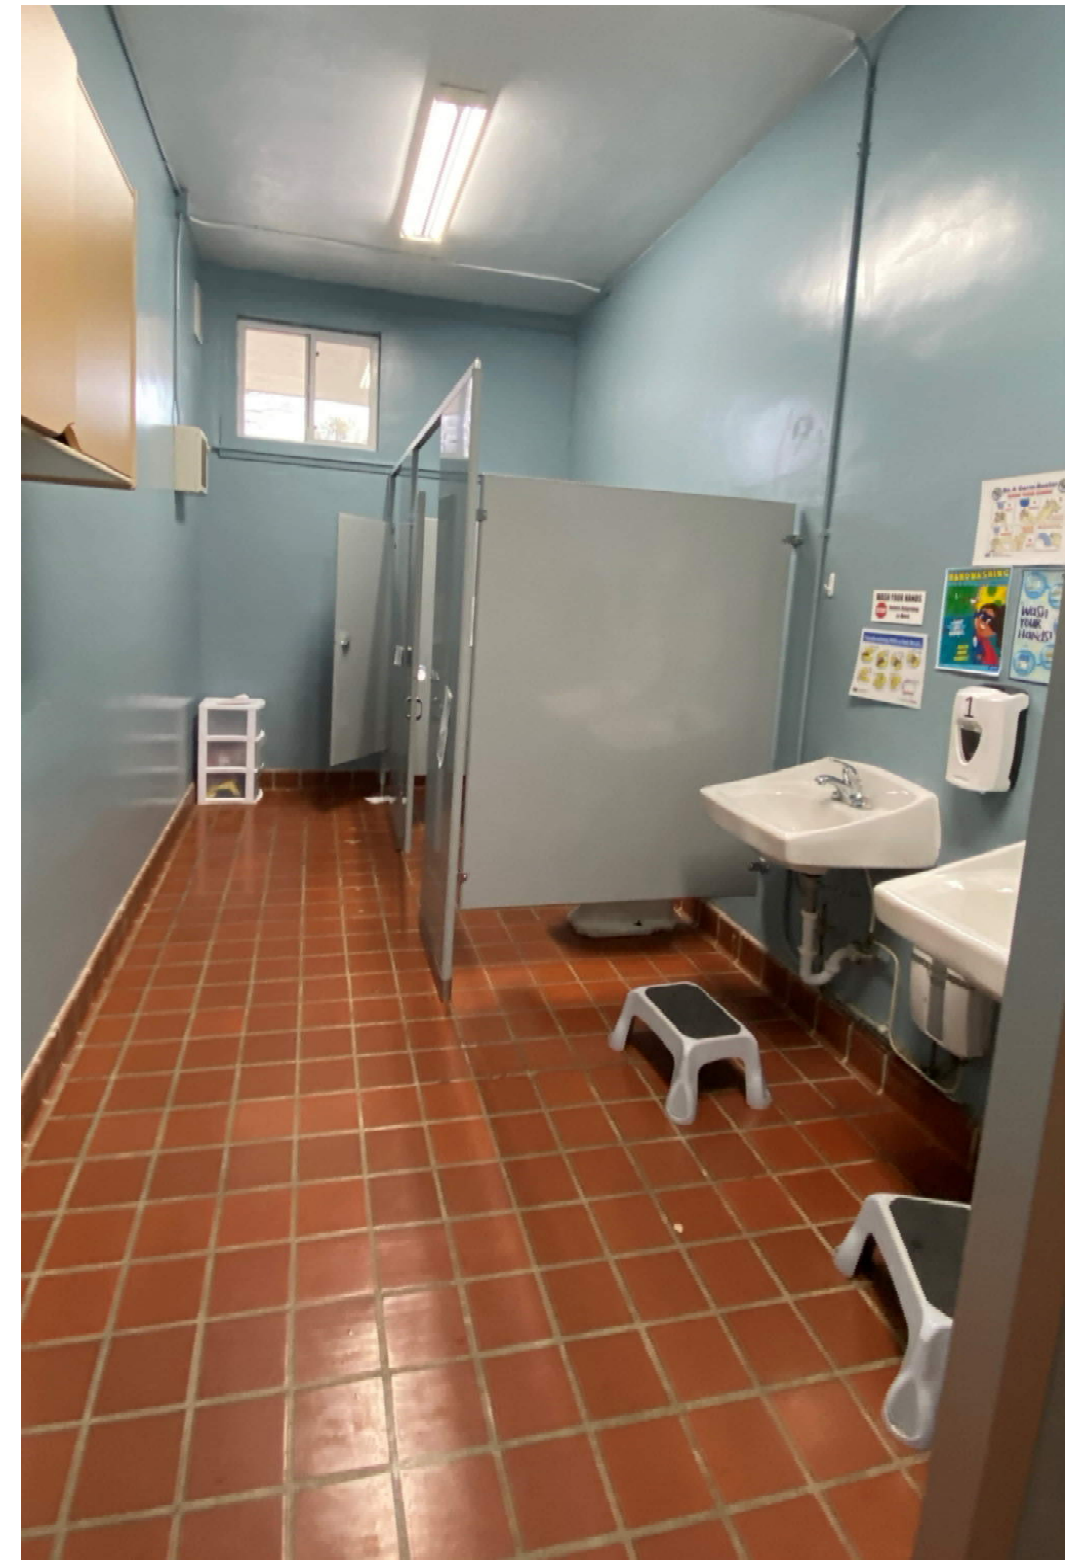
ADA upgrades needed in bathrooms.
May need to create 3 single-user rooms.
